City of Blair East Industrial Area Blight Study

Adopted XXX, XX, 2025 – Resolution XX-XXXX

Executive Summary

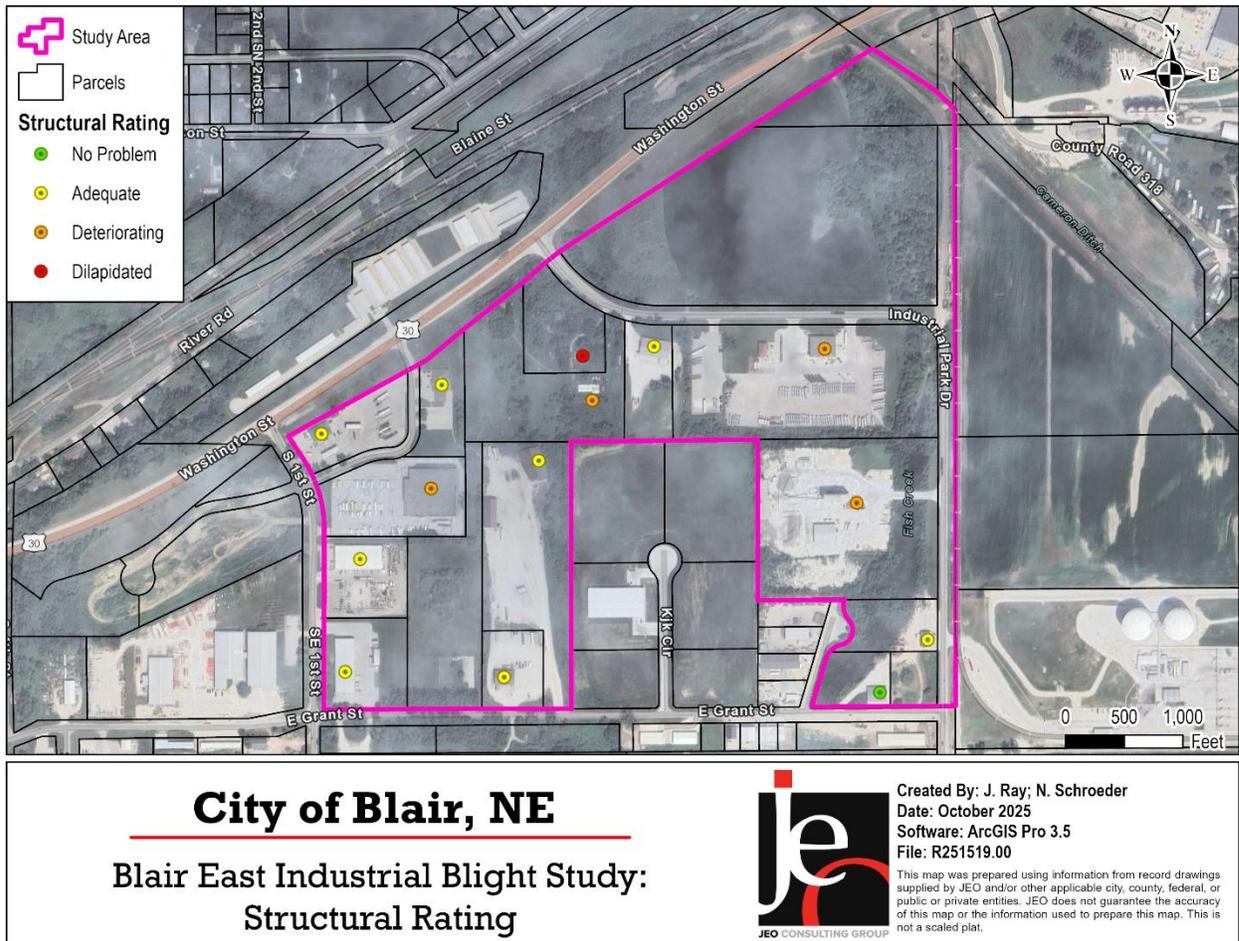
Figure 2, Structural Rating

The structures for each parcel within the East Industrial Area Blight Study Area were examined: one residential and thirteen commercial/industrial structures. Thirty-six percent of the primary structures within the designated study area were graded as deteriorating or dilapidated. Figure 2 illustrates the distribution of the structural ratings within the study area. This is considered a significant contributing factor.

Thirty-six percent of the primary structures within the designated study area were graded as deteriorating or dilapidated. Figure 2 illustrates the distribution of the structural ratings within the study area. Figure 2 illustrates the distribution of the structural ratings within the study area. This is considered a significant contributing factor.

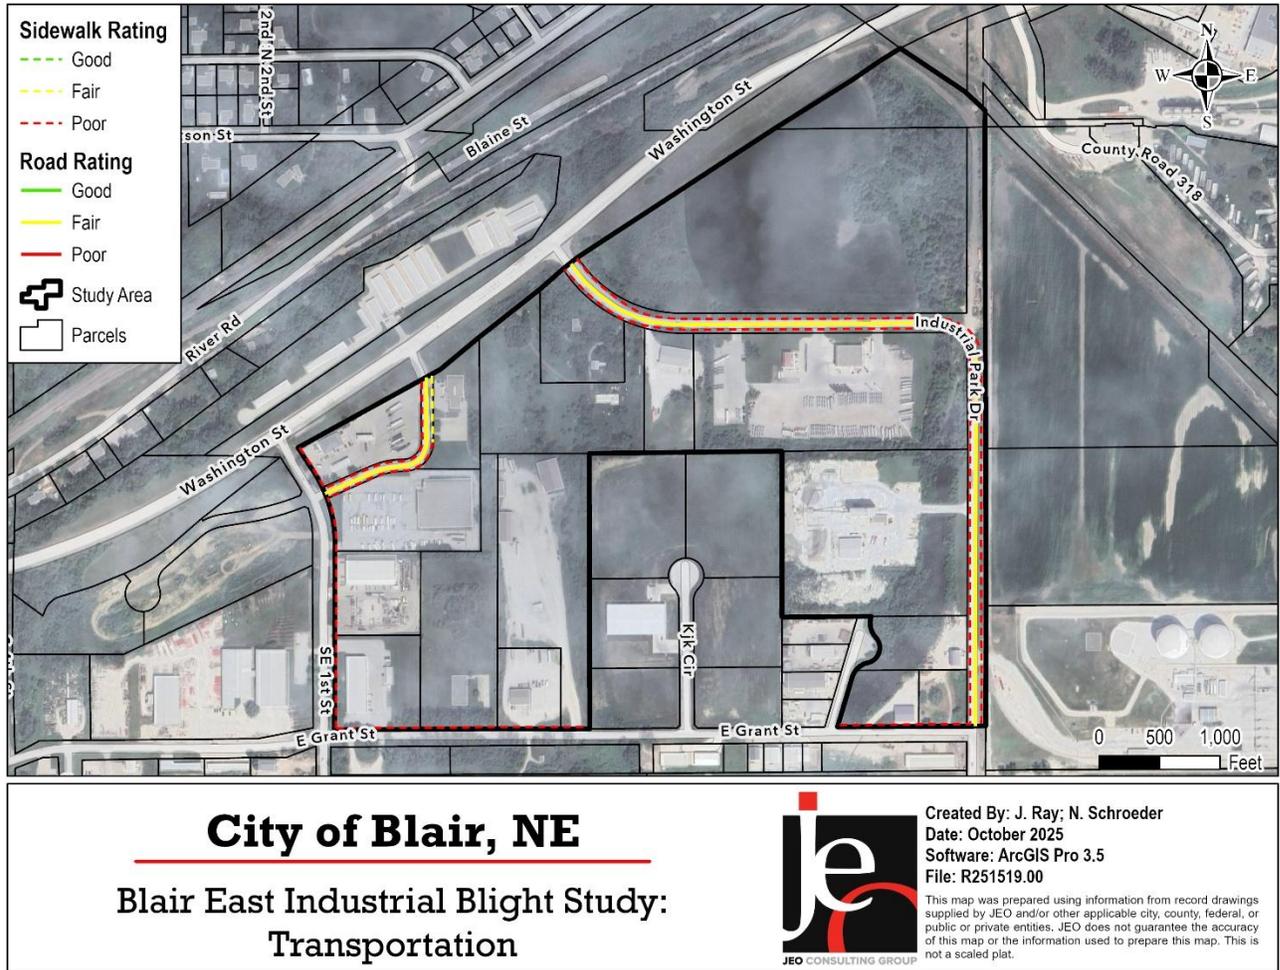
Figure 3, Transportation

Street and sidewalk conditions within the East Industrial Area Blight Study Area were evaluated in relation to the provision of safe and efficient public circulation and access, and regarding ease of travel and appearance. The transportation infrastructure conditions are illustrated in Figure 3.

The surface of the streets is generally in good condition. However, the majority are rural section roads and lack sidewalks and curb and gutter. The area lacks the rectilinear grid with street connections to the city; thus, limiting access through the area. It is considered significant enough to warrant a contributing factor designation.

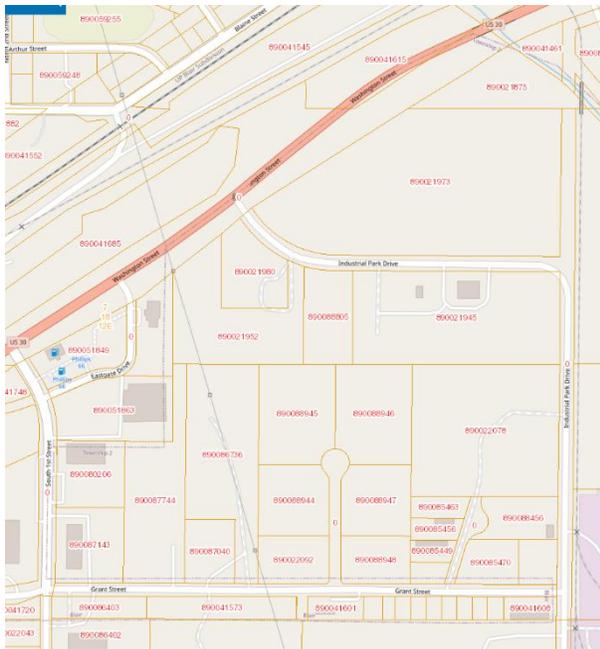
Obsolete platting

The northern portion of the area contains a parcel that is too large and obsolete for urban development.

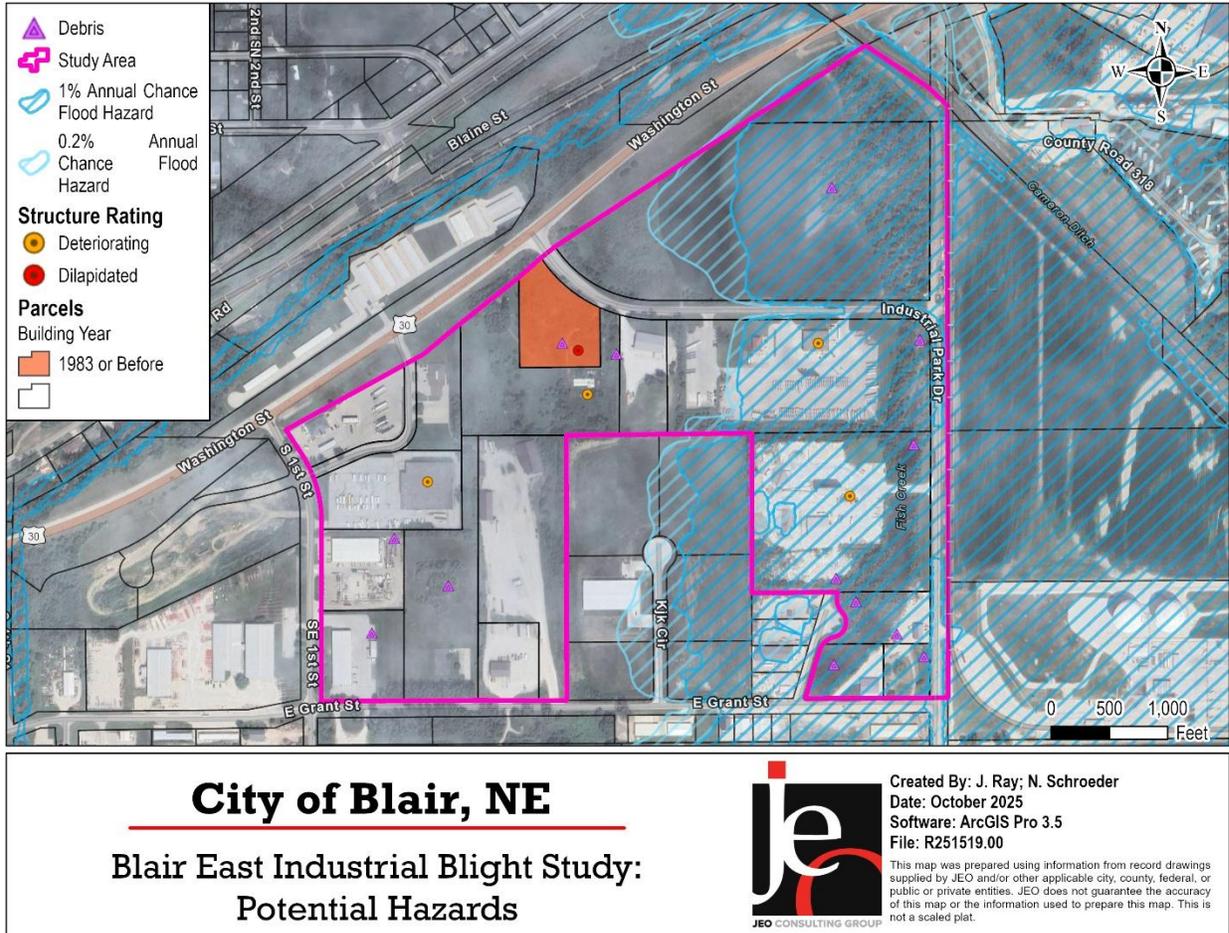
Figure 4: Potentially Hazardous Conditions

As a result of these contributing factors, conditions which endanger life or property is considered a contributing factor.

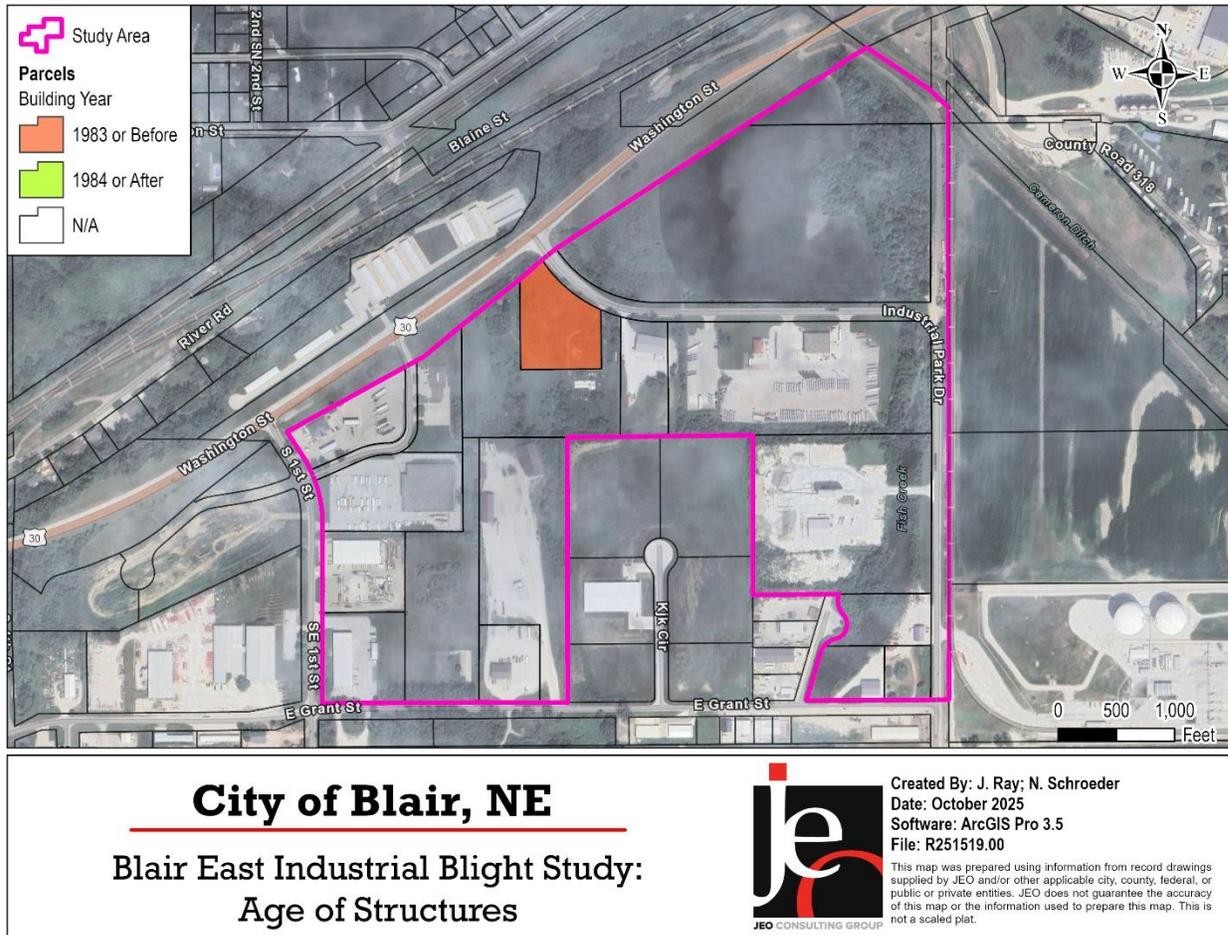
Figure 5: Age of Structures

The age of the residential structure is 135 years old according to the Washington County Assessor. This is considered a substantial contributor to the East Industrial Area Blight Study Area to be considered blighted.

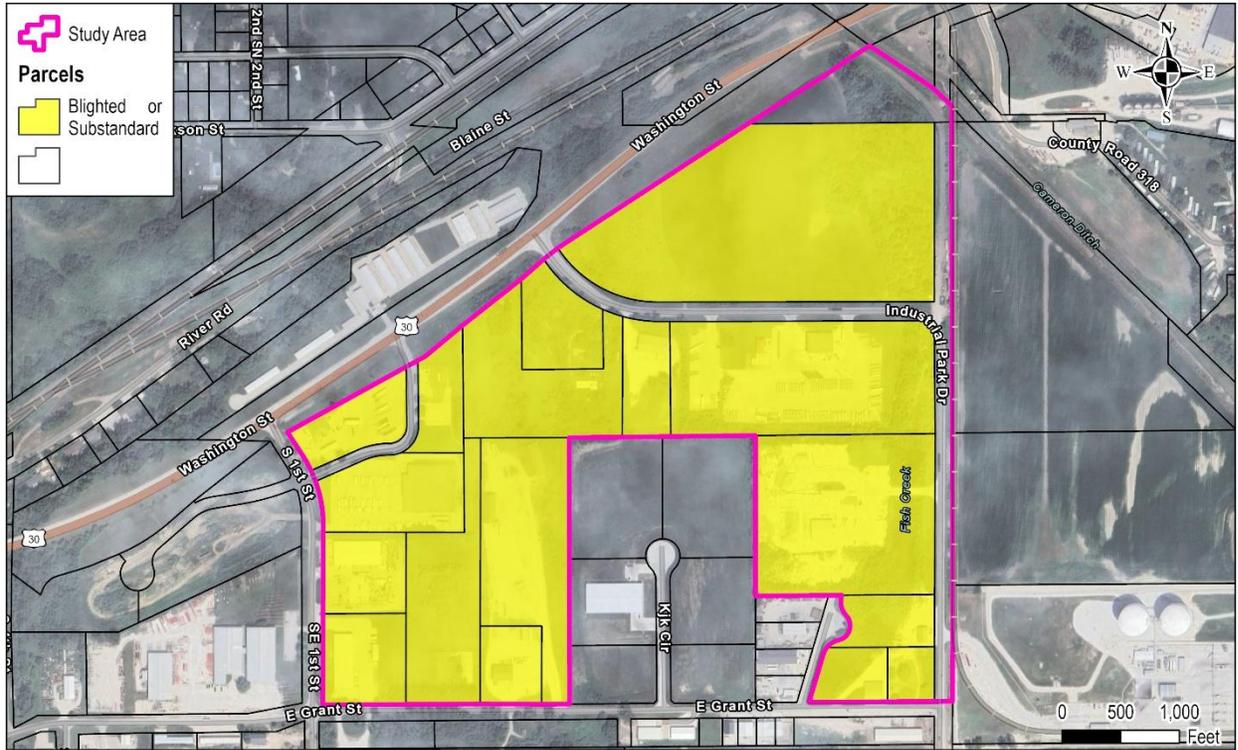
Figure 6: Parcels Showing Blight and Substandard Criteria

City of Blair, NE
Blair East Industrial Blight Study:
Characteristics of Blight & Substandard Area

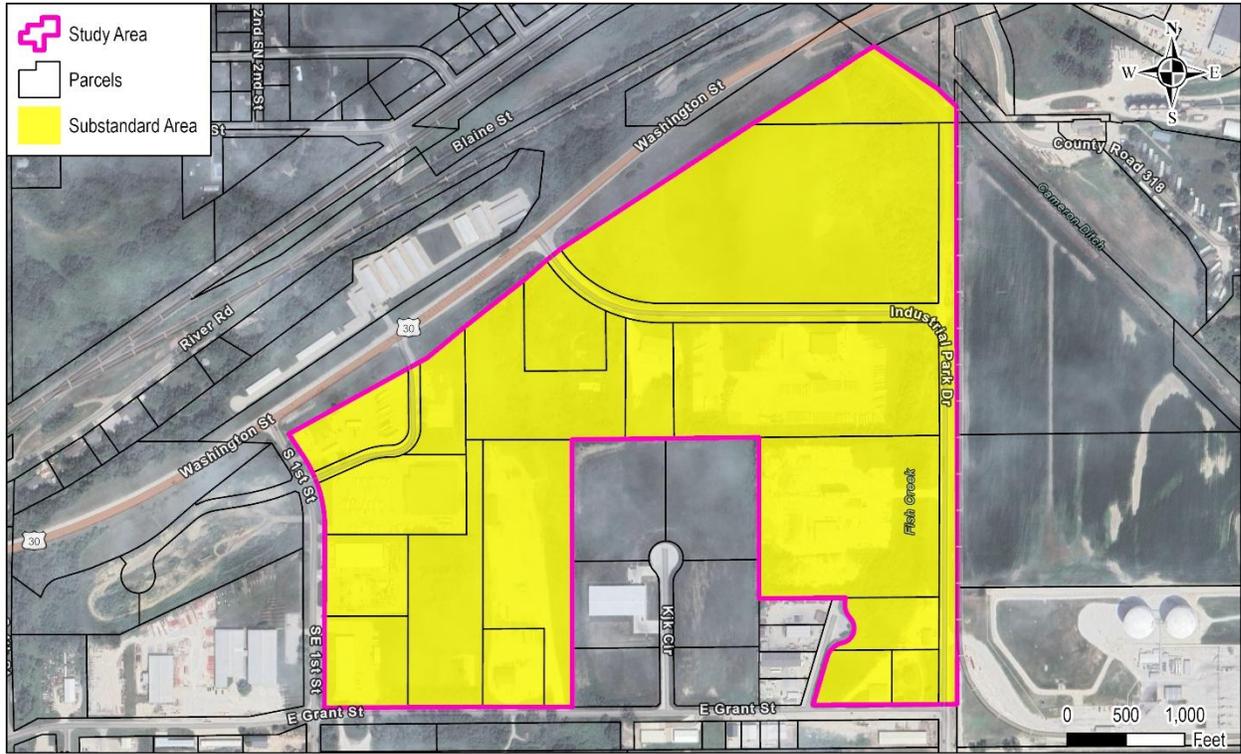
Figure 7 Recommended Blight and Substandard Designation

Blair East Industrial Blight Study: Recommended Blight & Substandard Area
